PERATION

GREENHOUSE

SCIENTIFIC DIRECTOR'S REPORT

ANNEX 3.2 U. S. NAVY STRUCTURES

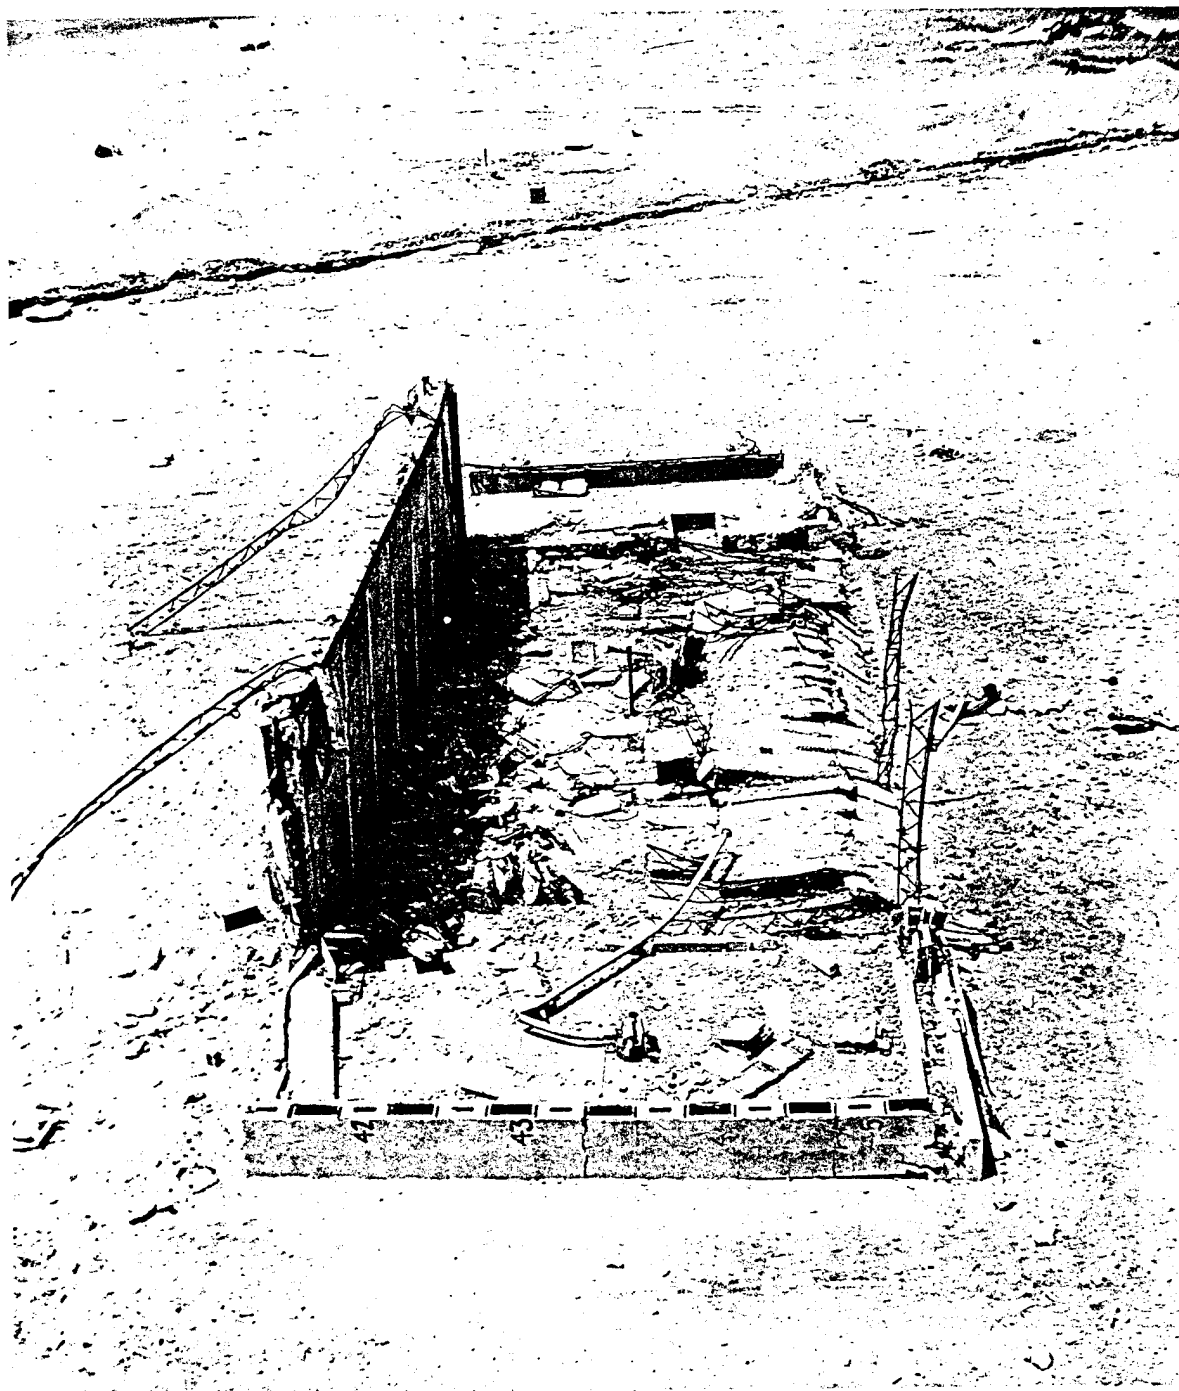
Fig. L.211 Side View of Structure after Blast, Structure 3.2.3a. Pattern of failure in front wall is clearly evident. Attitude of the two remaining roof trusses shows how roof tilted up and flipped over backward.

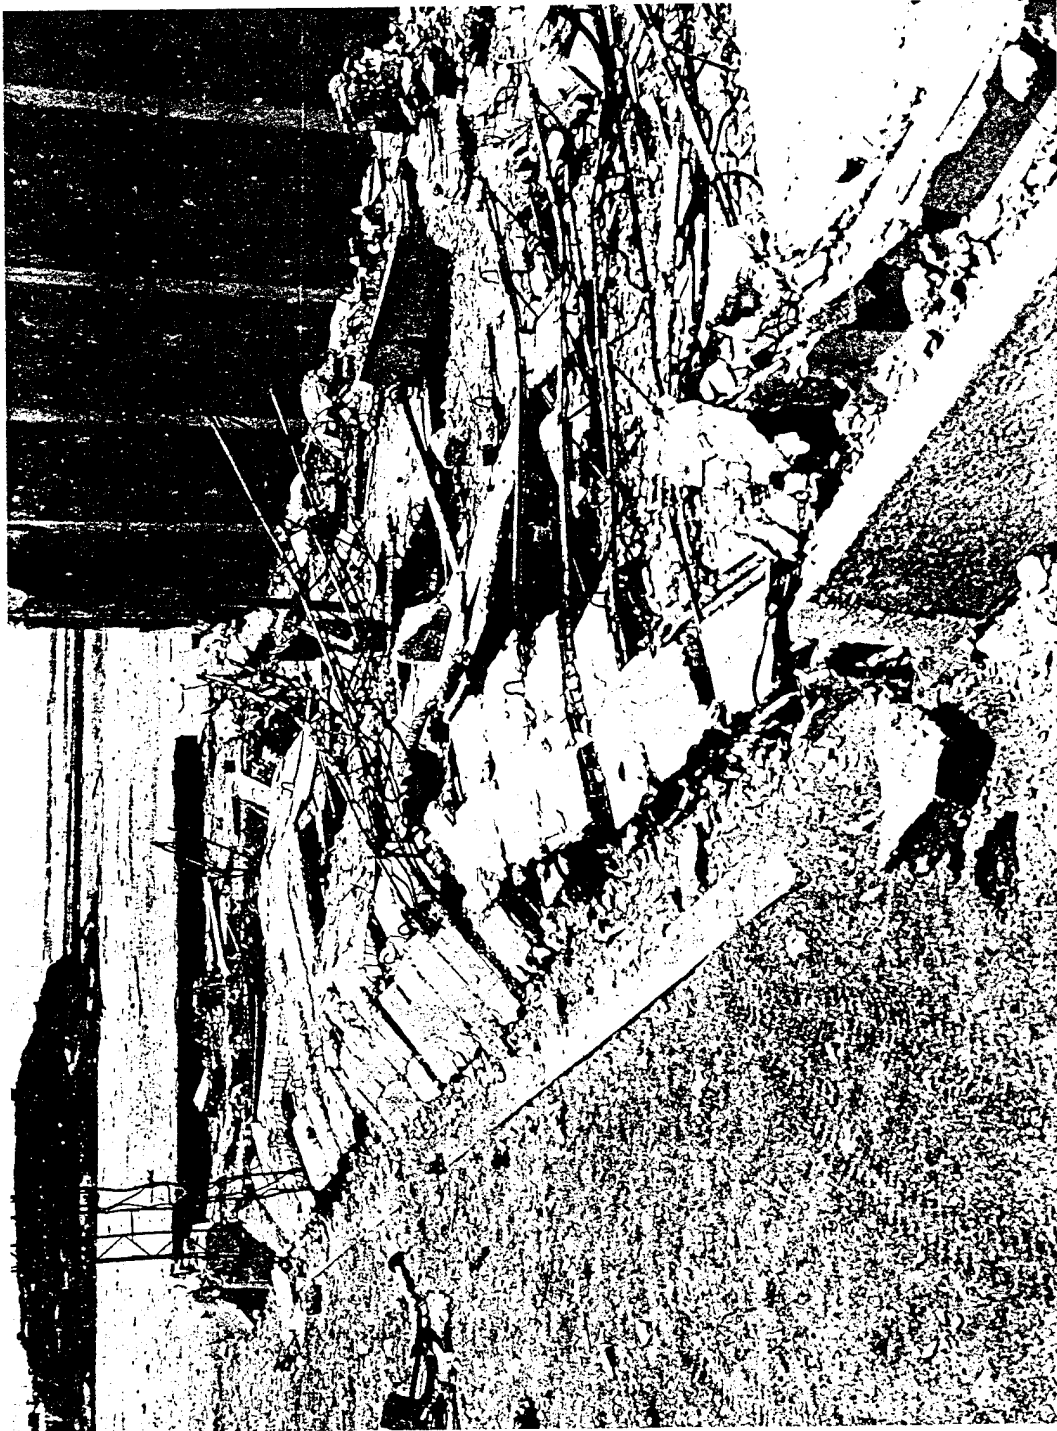
Fig. L.212 View along Front Edge of Foundation, Structure 3.2.3a. Note severe bending of front-wall panels at base. General "S" shape of front-wall trusses is clearly evident.

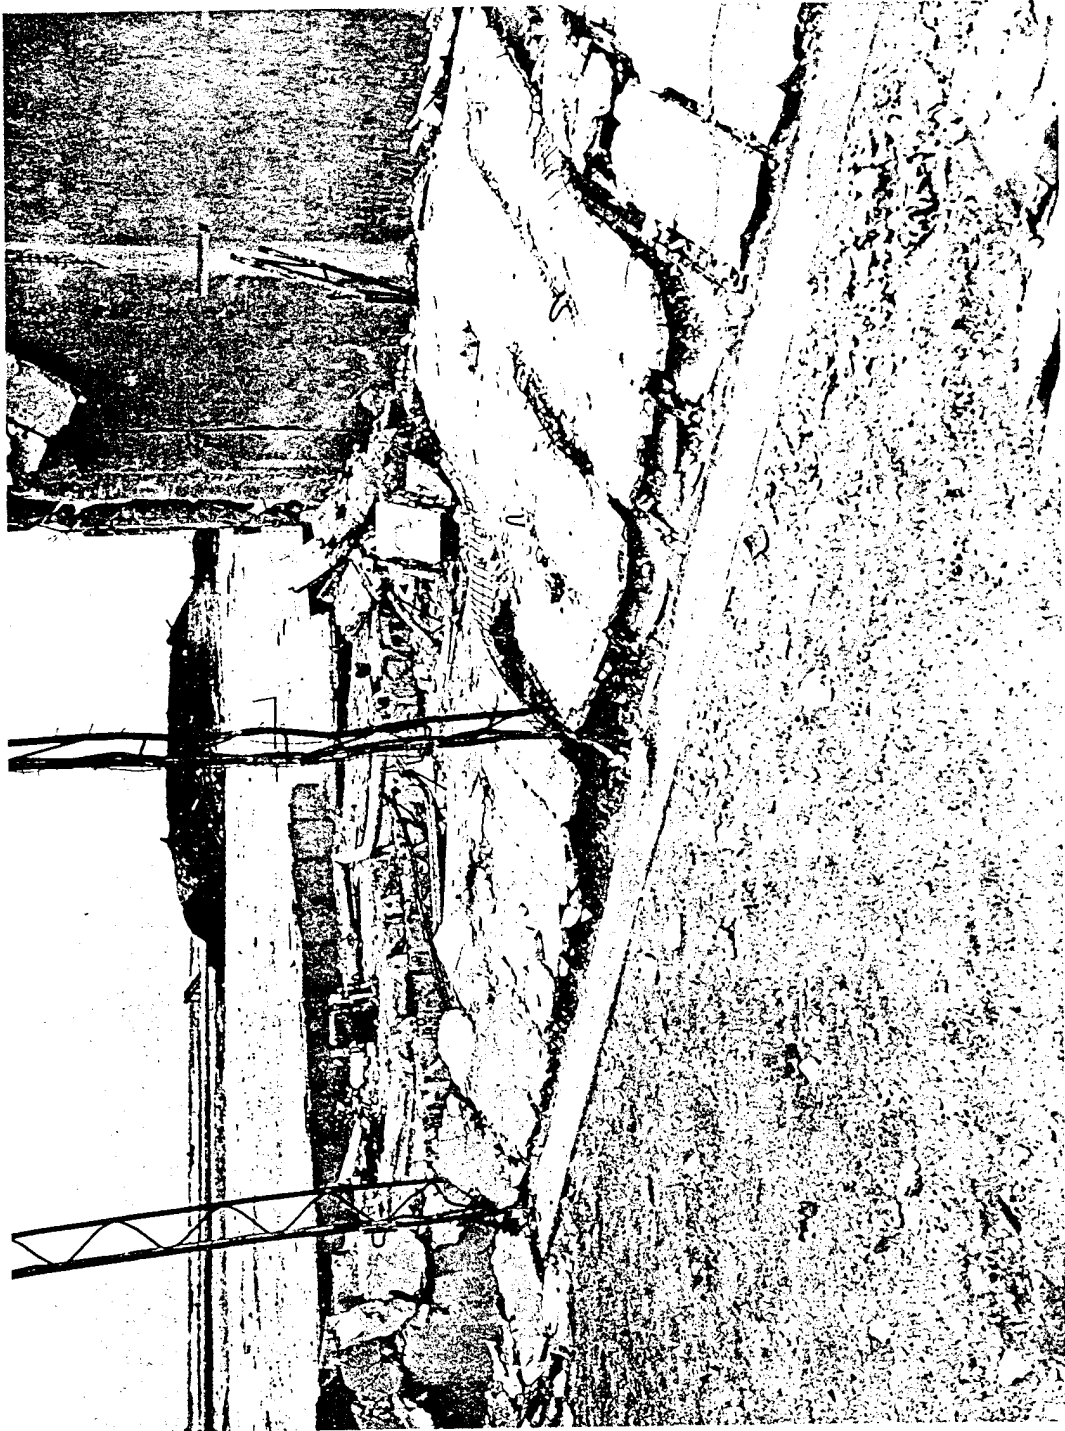
Fig. L.213 Lower Edge of Front-wall Panels, Showing Crushing of Cells and Trusses, Structure 3.2.3b. Note trusses still attached to foundation.

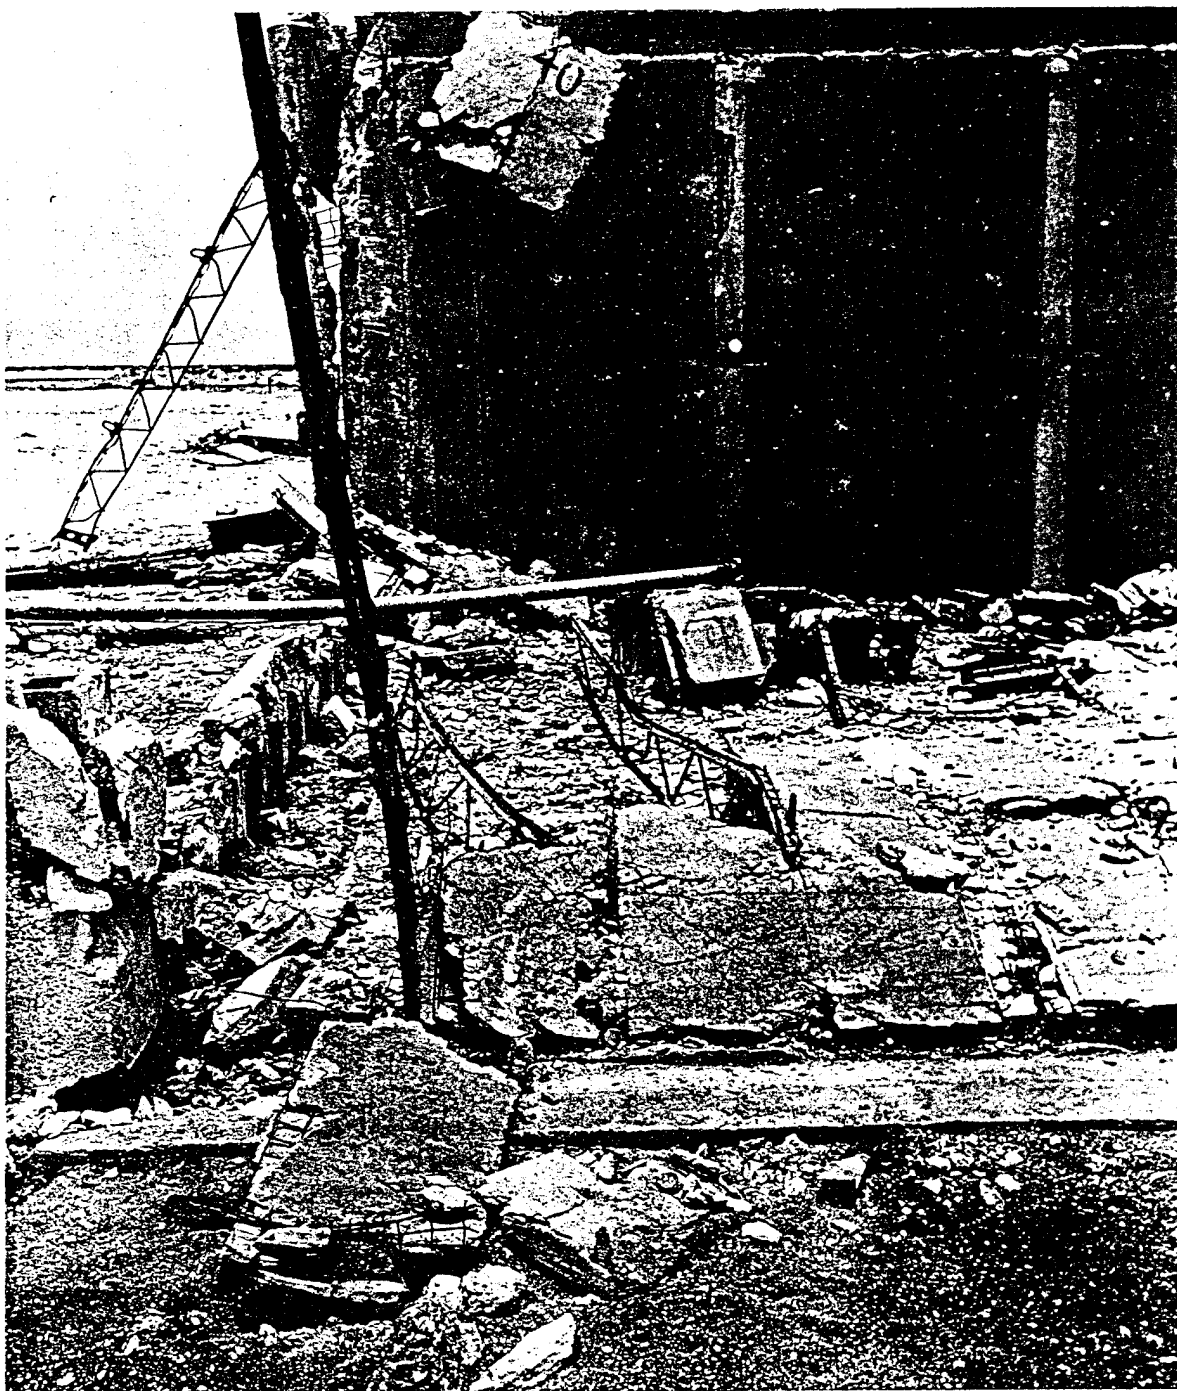
Fig. L.214 Left End of Front Wall, Showing Severe Crushing of Cells, Structure 3.2.3b. Note "S" shape assumed by trusses.

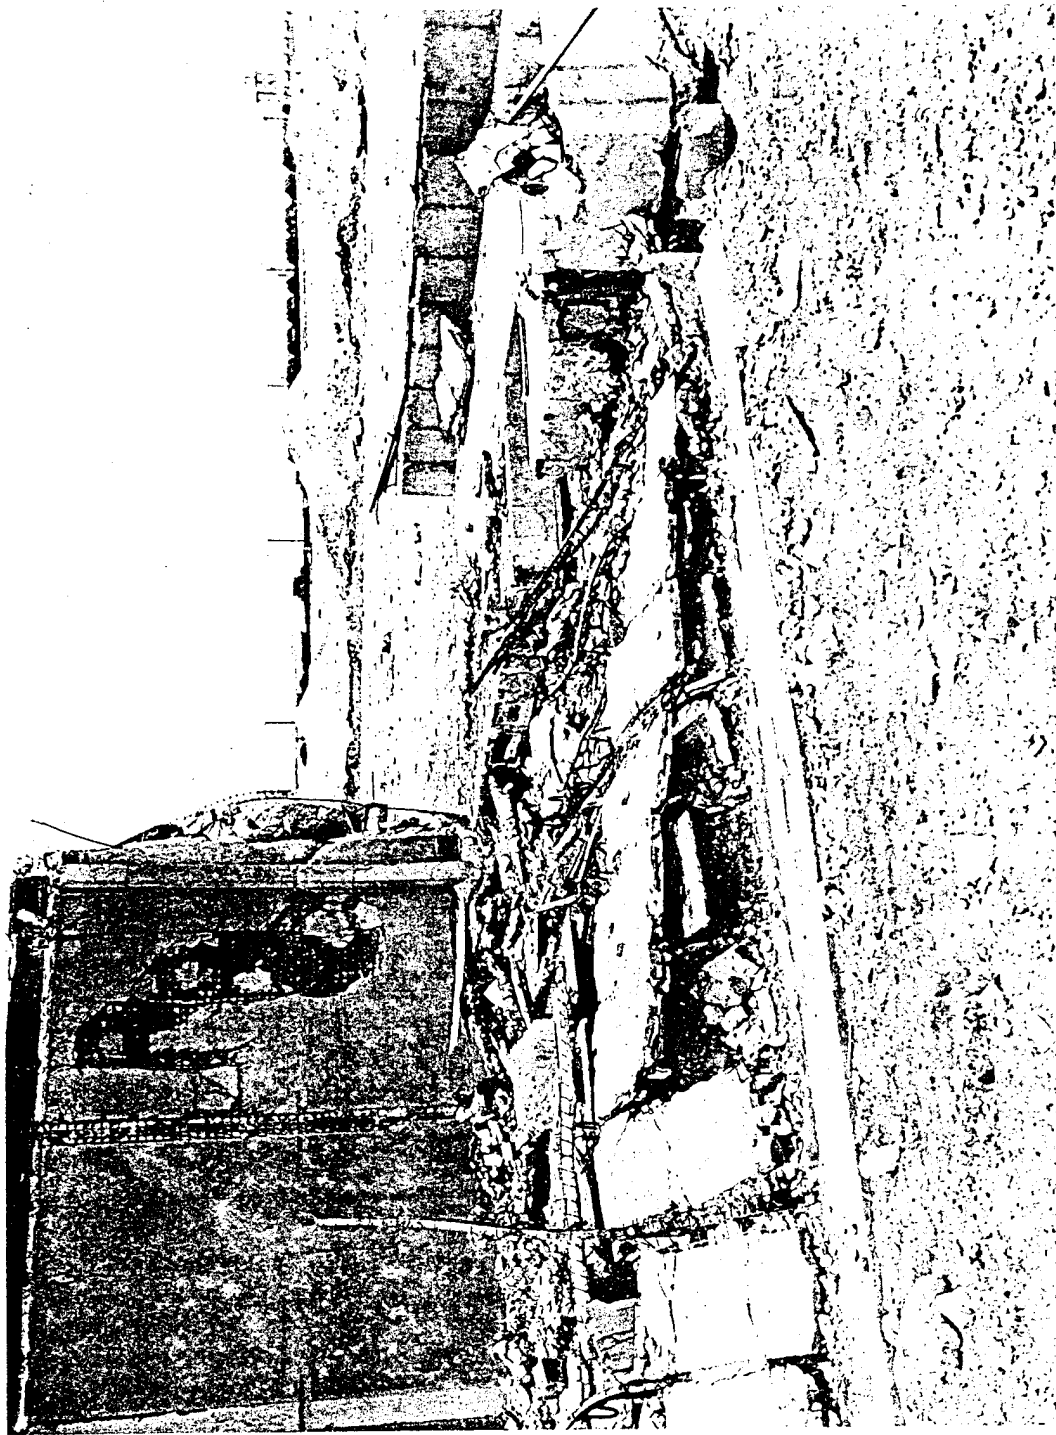
Fig. L.215 Right End of Front Wall at Foundation Line, Structure 3.2.3b. Cells are sprung open in one panel. Note where portions of right-hand front-wall panel struck the rear wall and broke loose large portions of concrete.

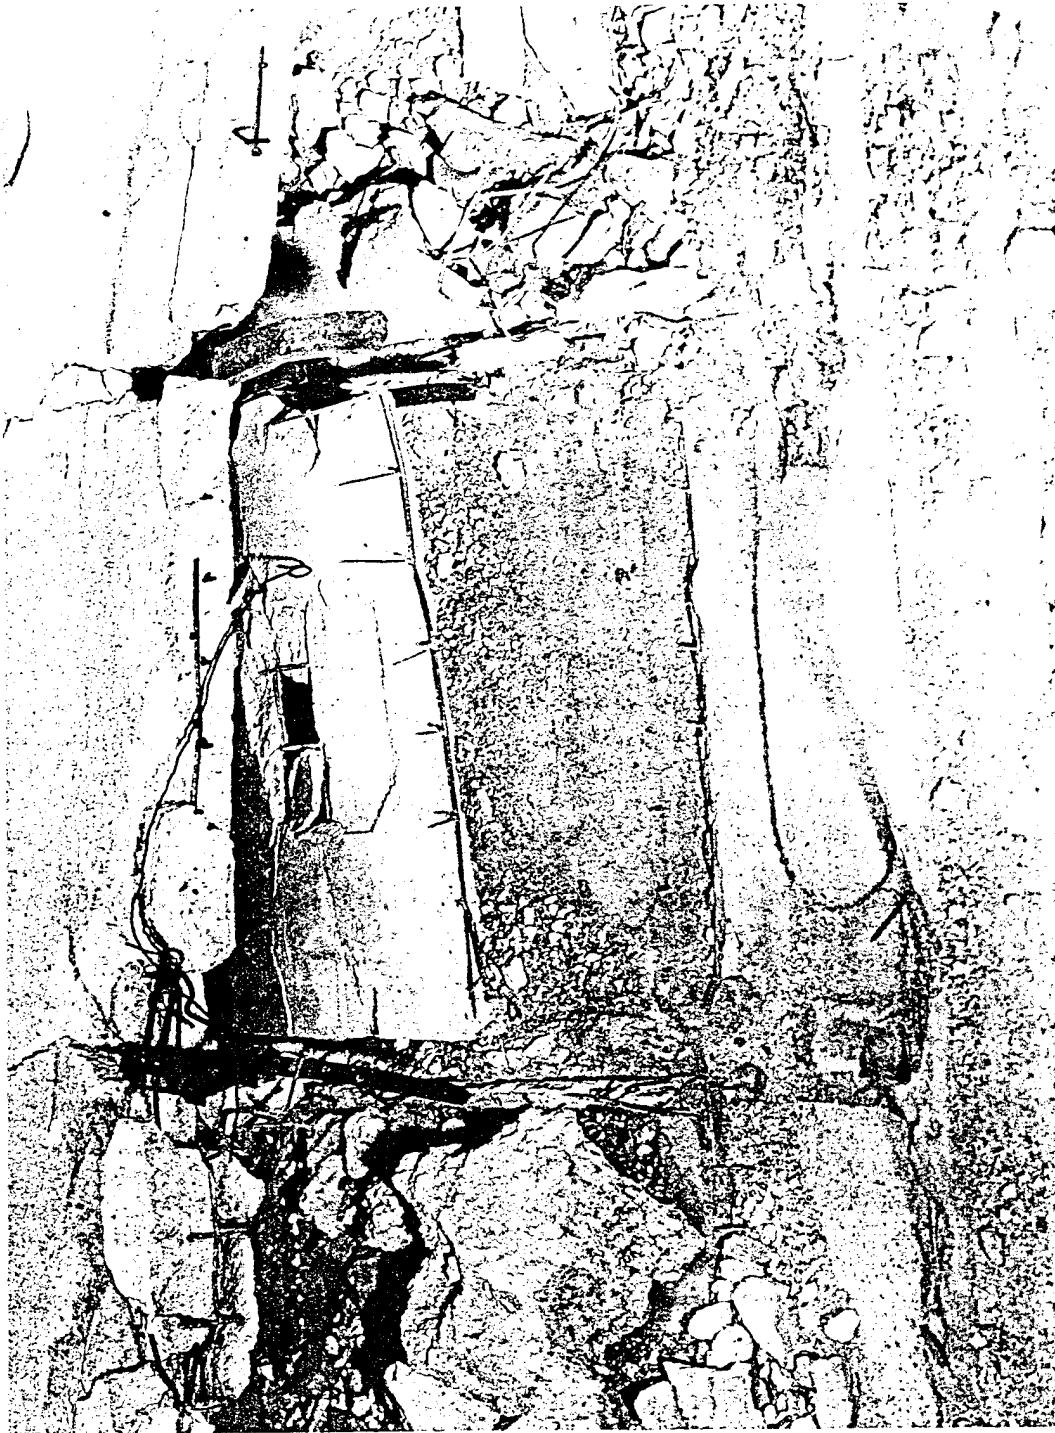
Fig. L.216 Detail View of Cell Pulled Loose from Its Anchorage, Structure 3.2.3b. Note also how truss failed in the weld.

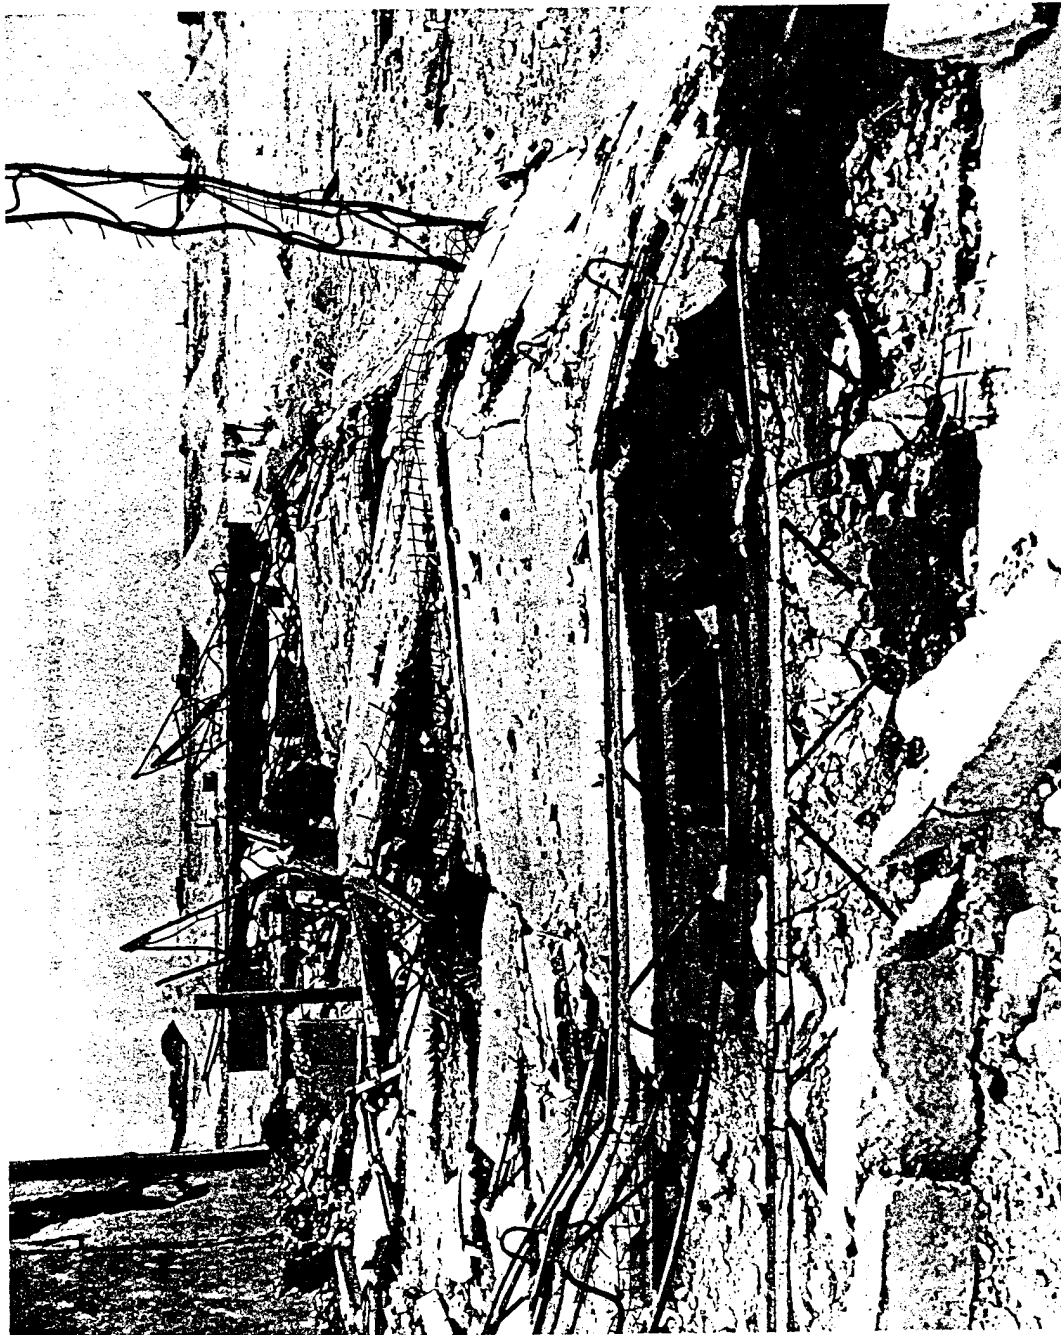
Fig. L.217 Side View of Front-wall Panels, Structure 3.2.3b. Typical "S" shape of panels and trusses is clearly visible. This shape was caused by initial deflection of panel before rupture and then reverse bending during rotation after rupture from the roof.

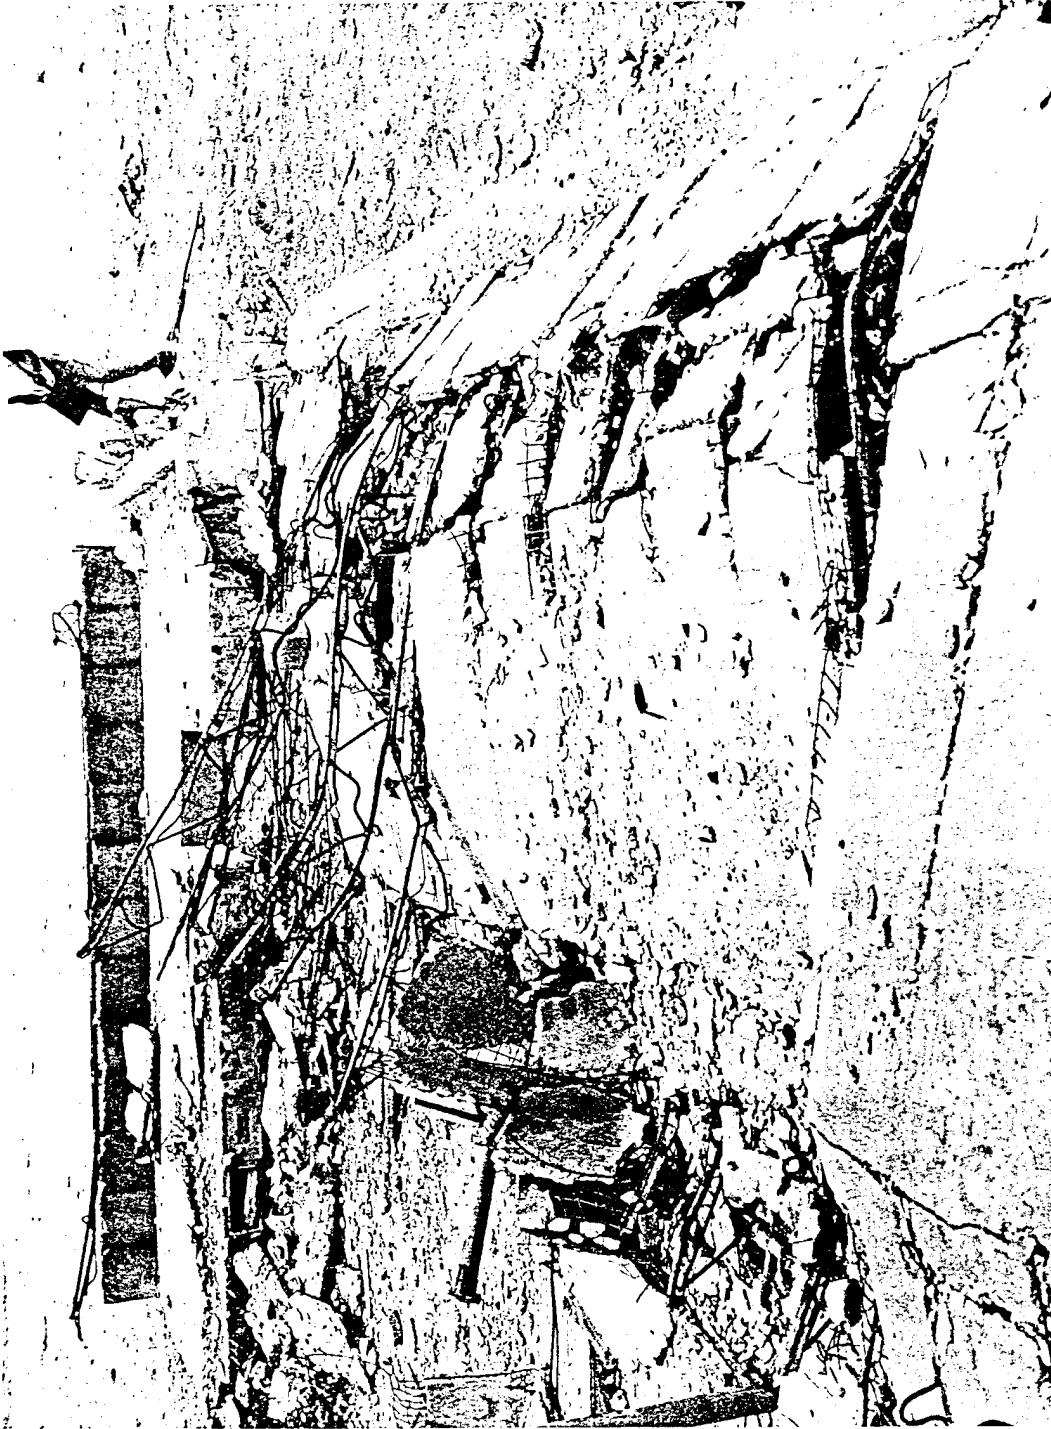
Fig. L.218 Left Side View of Front Wall, Structure 3.2.3b. Base of right end wall can also be seen.

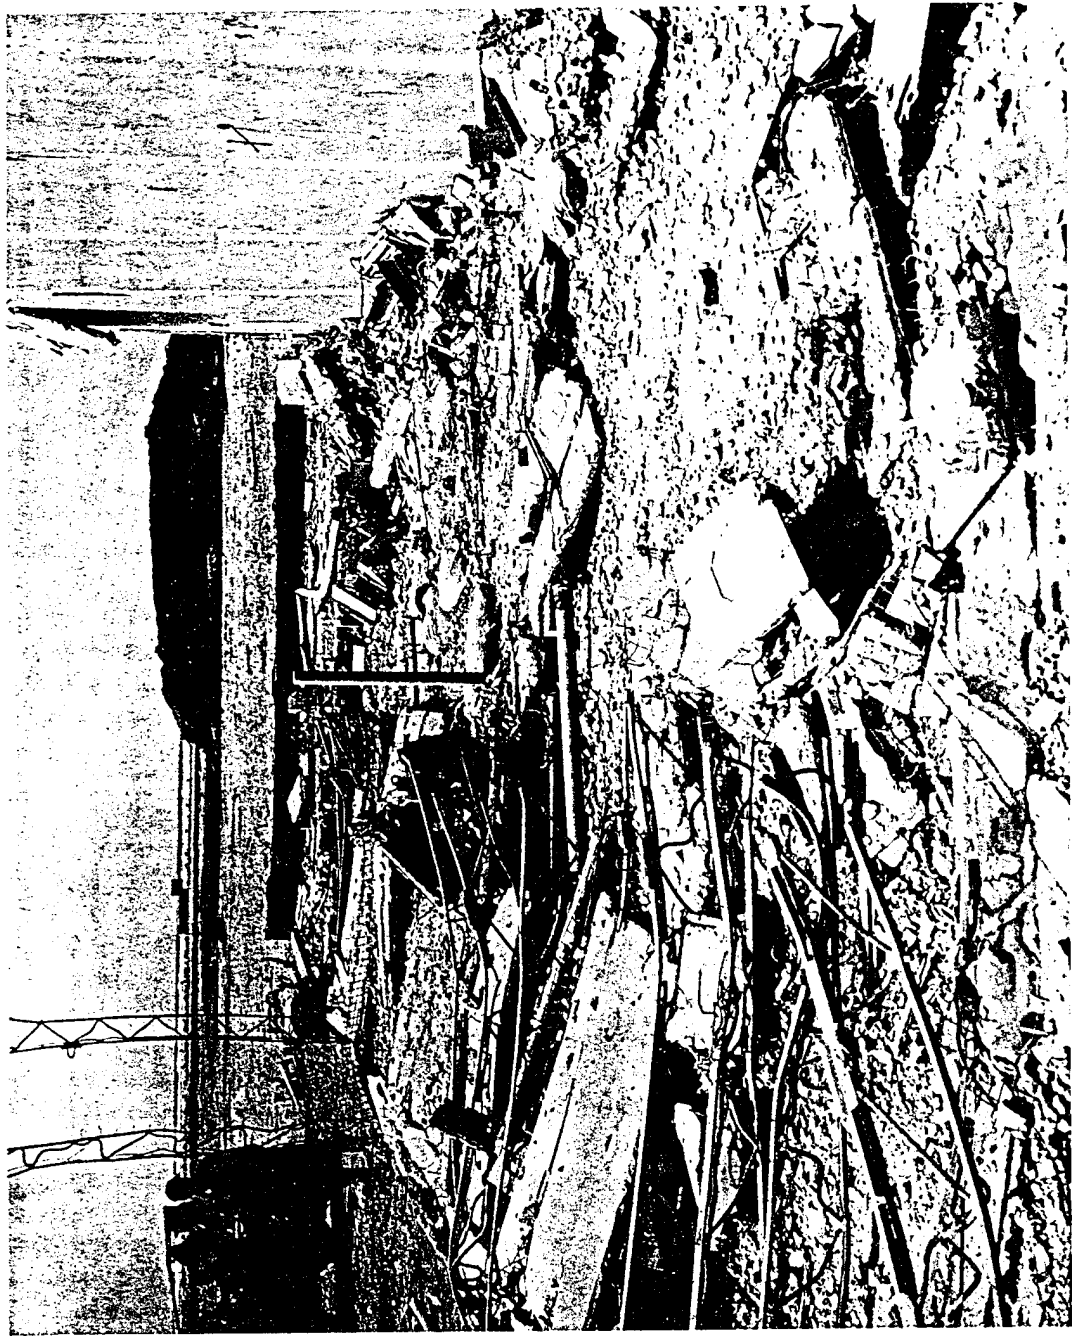
Fig. L.219 Right Side View of Front Wall, Structure 3.2.3b. Note debris piled against rear wall.

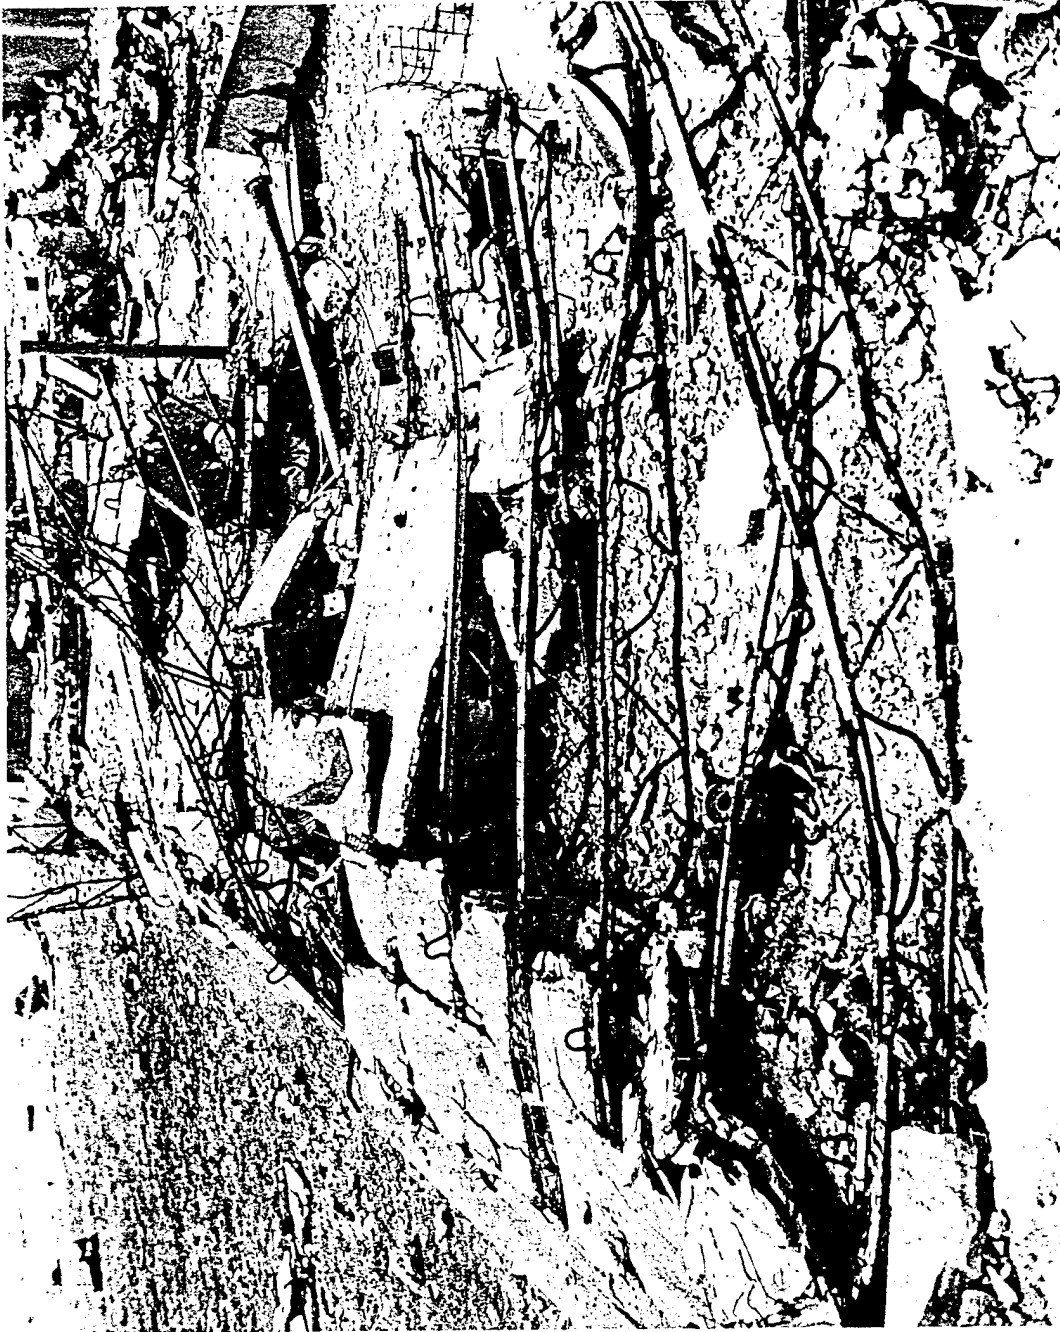
Fig. L.220 Right Side of Front Wall, Structure 3.2.3b. The missing portions broke loose during blast and struck the right-hand panel of the rear wall.

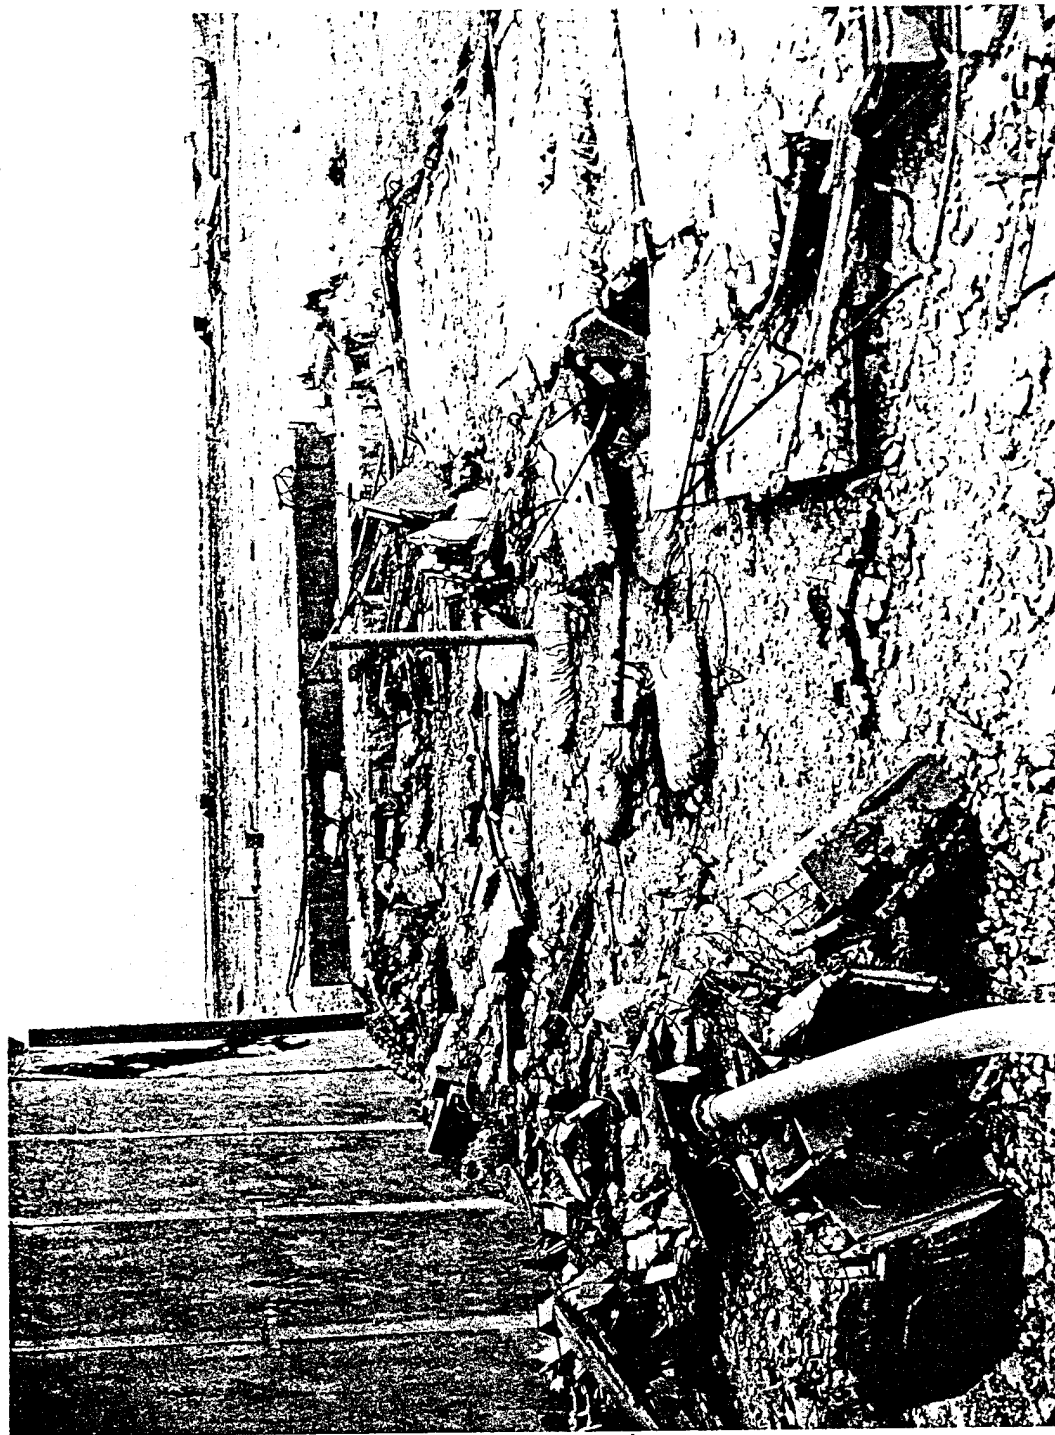
Fig. L.221 General View of Upper Edge of Front Wall, Structure 3.2.3b. This portion of wall suffered heavy damage when it was severed from the roof and also upon impact as it hit the foundation.

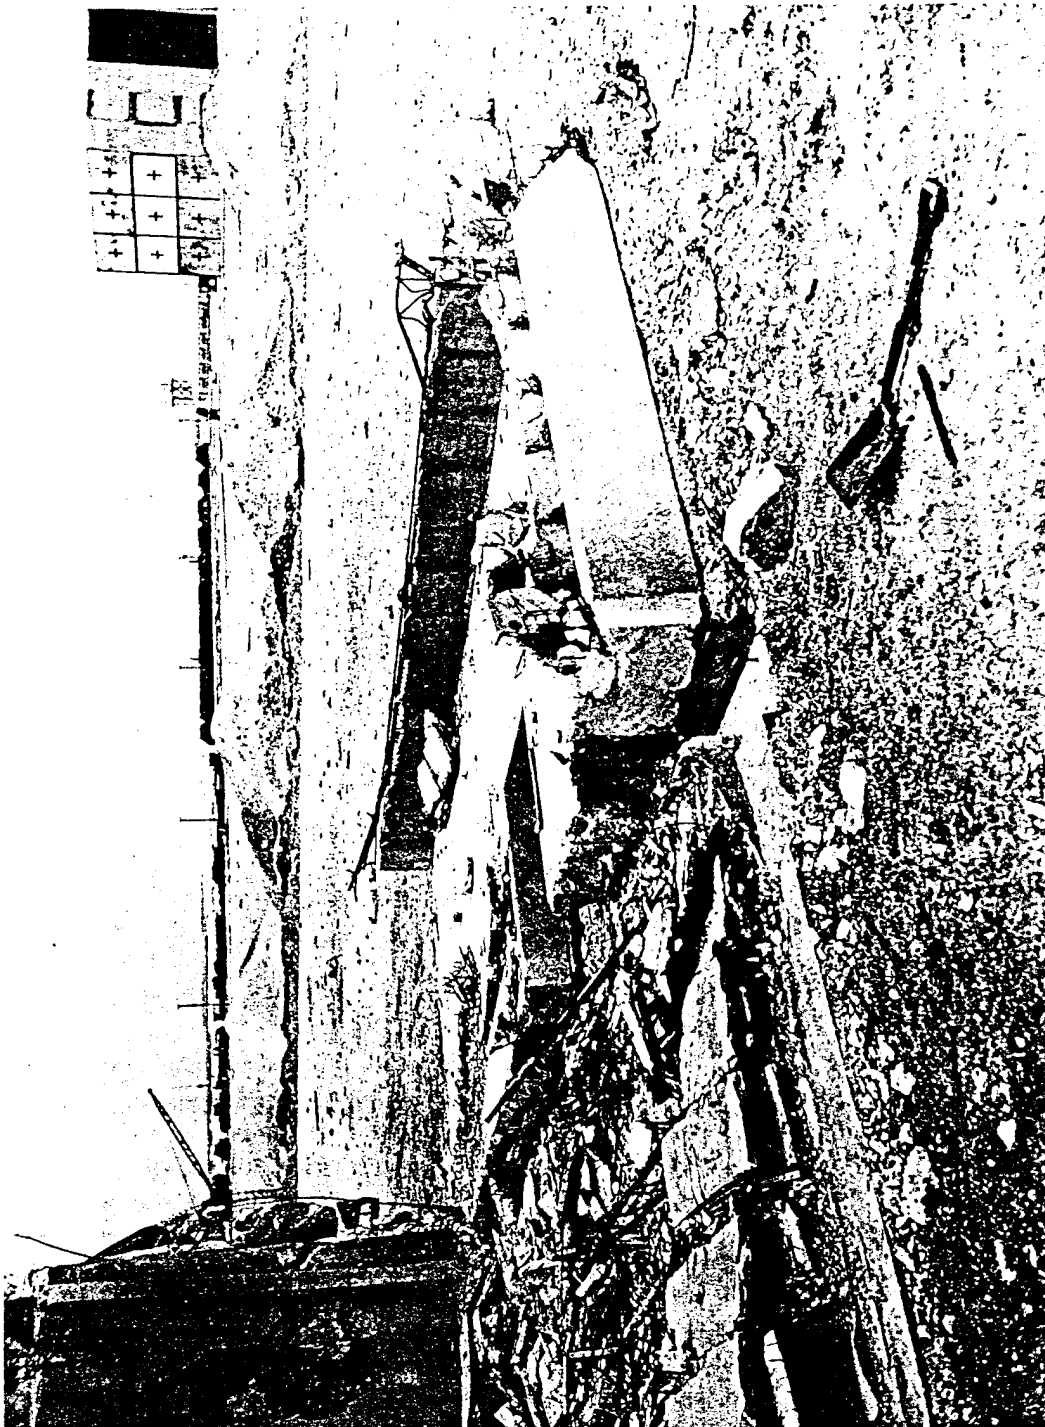
Fig. L.222 Right End Wall Rotated Outward to the Horizontal Position, but with No Lateral Displacement of the Base, Structure 3.2.3b. Note heavy crack in foundation at near corner of wall. See next photograph for detail.

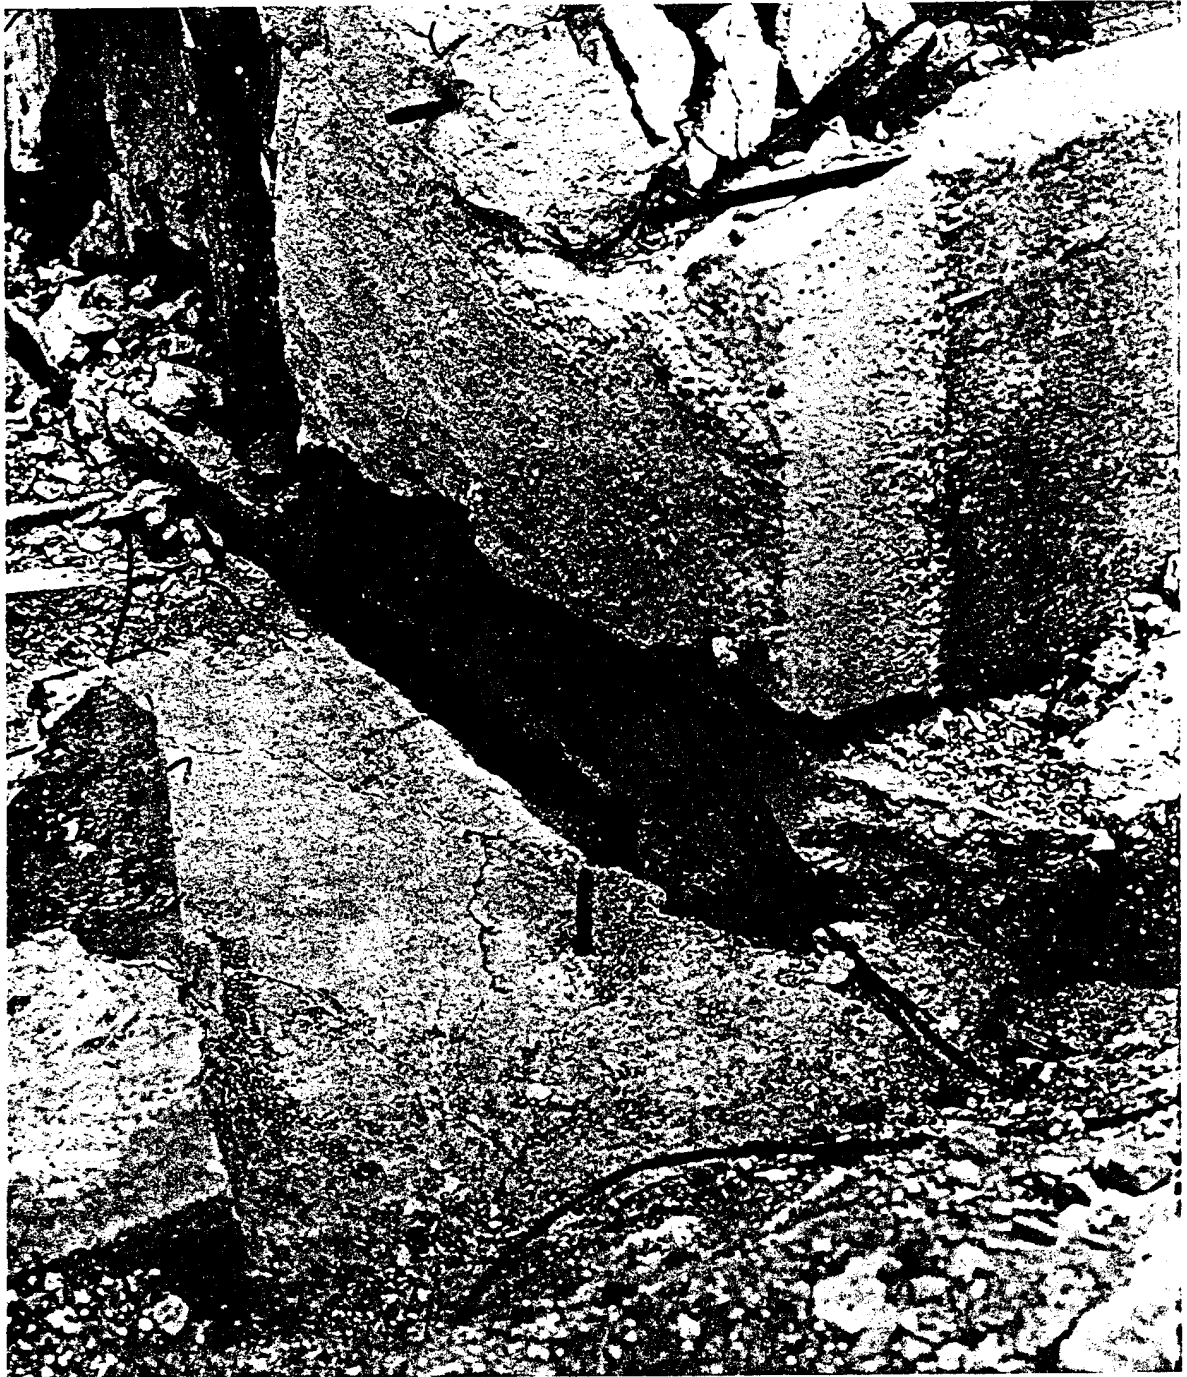
Fig. L.223 Detail View of 2-in.-wide Crack in Foundation at Front Right Corner, Due to Outward Rotation of End Wall, Structure 3.2.3b. Note tension (bending) failures of pilaster dowels.

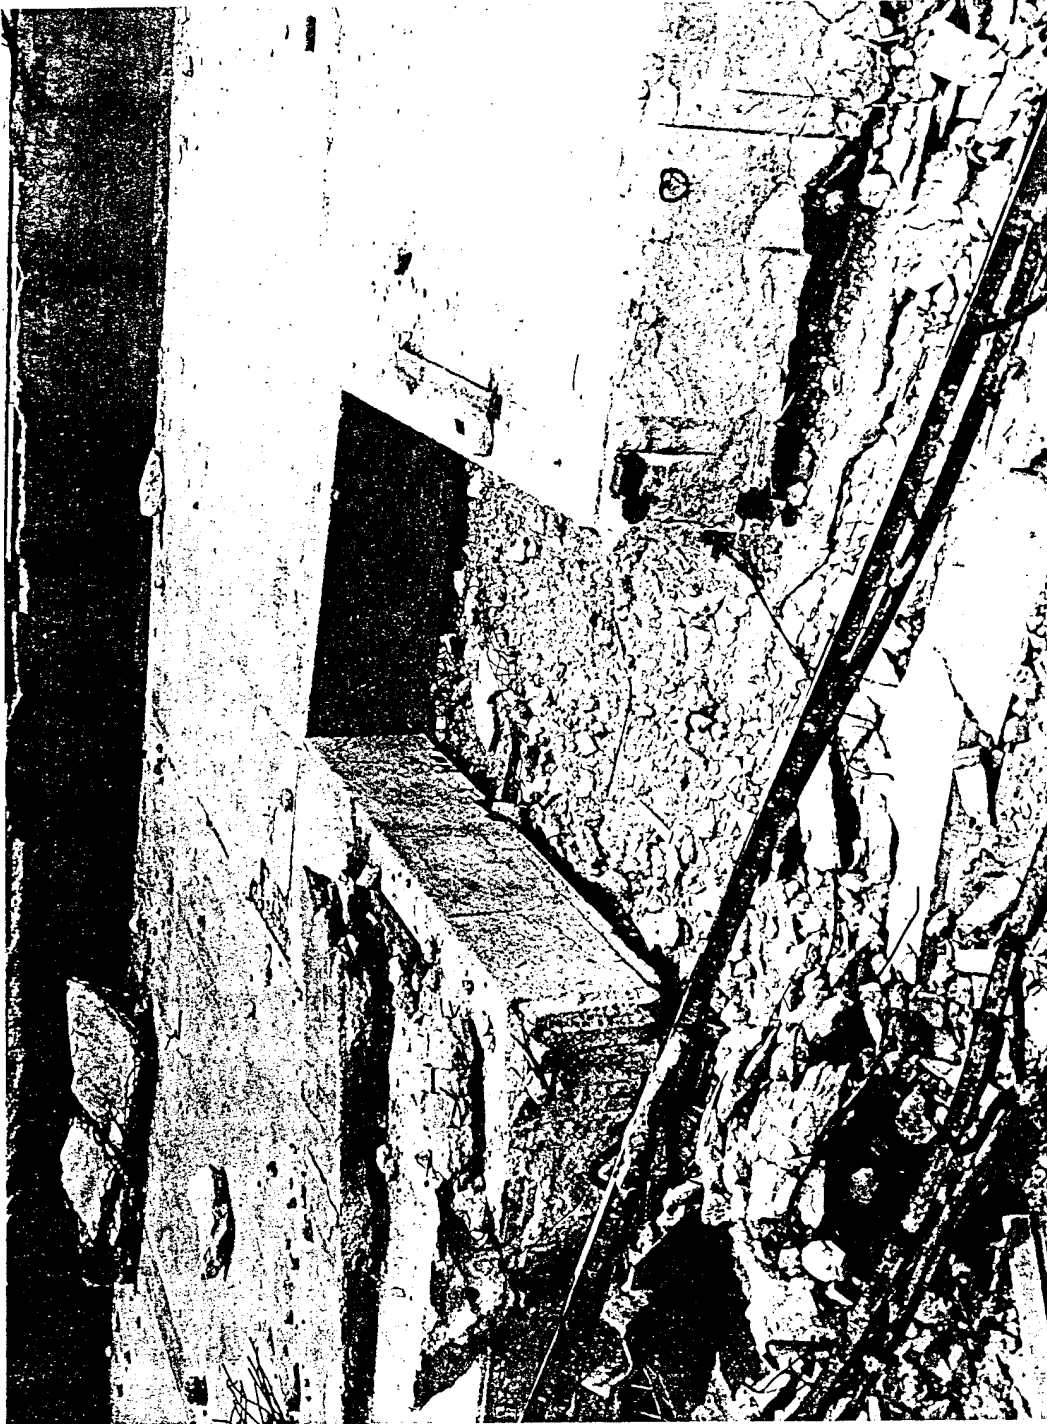
Fig. L.224 Base of Right End Wall, Structure 3.2.3b. Trusses pulled loose from channel anchorage. Note the practically undamaged condition of the panels in this wall.
